# Inspection Report

## Condominium Sample Report

**Property Address:**  
2600 Stutz Rd #200  
Dallas TX 75235

# PROPERTY INSPECTION REPORT

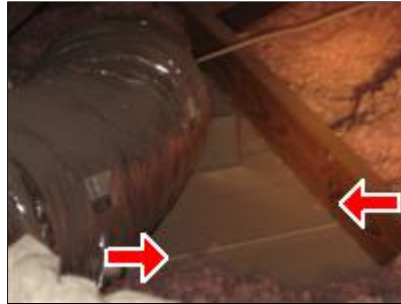
D. Picture 1

(1) Insulation missing between ceiling joists inside attic space. Lack of insulation can affect efficiency of heating and cooling levels if not present at recommended locations. Recommend adding insulation as necessary by a qualified expert.(Picture 1)

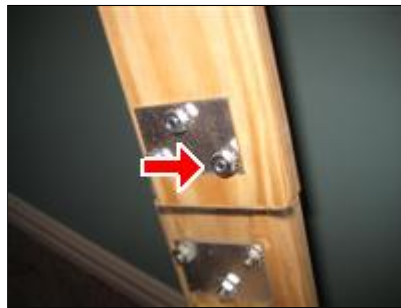
D. Picture 2

(2) The pull down stairs have loose hardware. Injury could result if not repaired. A qualified person should repair or replace as necessary.(Picture 2)

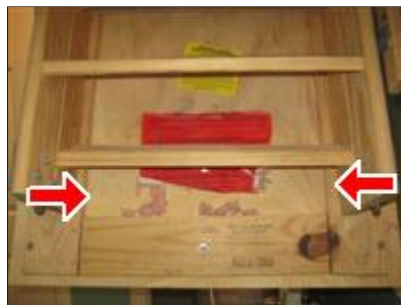
D. Picture 3

(3) **FYI (For your information):** Insulation missing at back of attic stair access. Energy loss can occur from this location that can affect heating and cooling efficiency levels within the structure if not corrected. Recommend adding insulation as necessary for efficiency reasons.

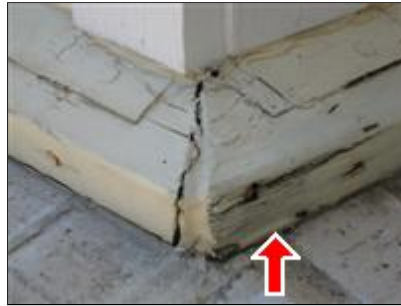
E. Picture 1

(1) Deterioration in wood trim at right side (Facing front) of structure. Recommend replacing rotted wood and sealing these areas as necessary to prevent further deterioration.(Picture 1)

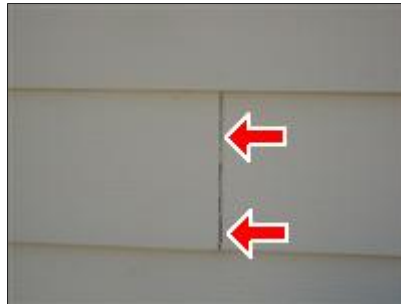
E. Picture 2

(2) Caulking separation between seams on horizontal siding around outside of structure. Open penetrations may allow moisture, insects, and/or pests to enter if not corrected and maintained as needed.(Picture 2)

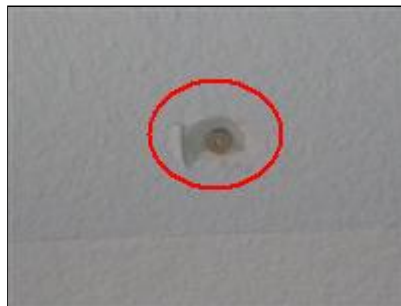
F. Picture 1

(1) Nail-pops on ceiling drywall in back bedroom at third floor level. Nail-pops are common due to natural settlement, which is considered cosmetic, and can be corrected if necessary.(Picture 1)

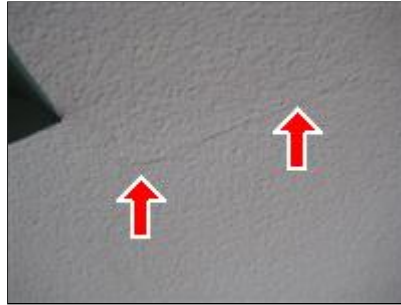
F. Picture 2

(2) Small stress-crack(s) in ceiling drywall at second floor living area. Settlement crack(s) are common in newer homes during the natural settlement process, and can be corrected if necessary.(Picture 2)

**NOTE:** If further concerns arise, or the crack(s) become larger, it is recommended that additional evaluation(s) and/or services be performed by a qualified expert.

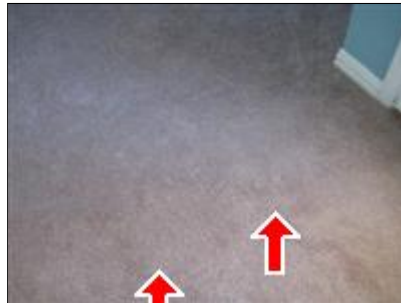
F. Picture 3

(3) Uneven spots under carpet where padding build up may be present, or is not properly installed, at master bedroom. Opinions on this type of condition may vary and can be corrected if necessary.(Picture 3)

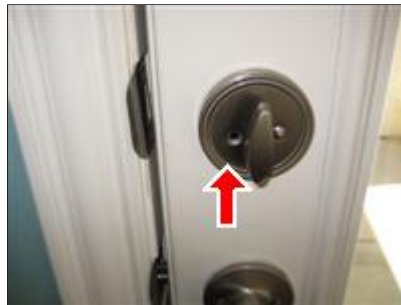
G. Picture 1

Deadbolt missing hardware and may need service or replacement at second floor level patio access.(Picture 1)

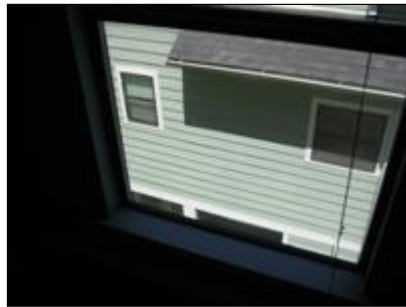
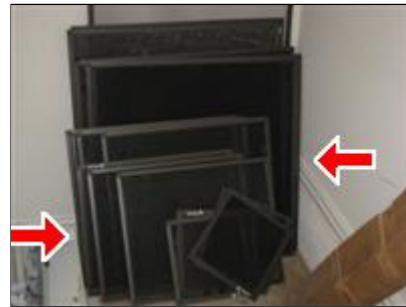
(2) Window screens detached or are removed at front and back of structure. Screens are located in garage closet under stairs. Recommend service as necessary.(Picture 1)(Picture 2)

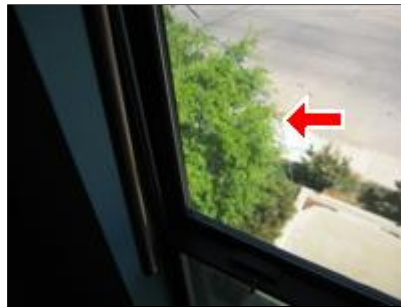
H. Picture 3

(3) Inside window pane cracked at upstairs master bedroom. Recommend replacement as necessary.(Picture 3)

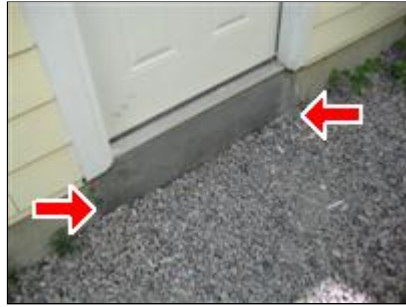
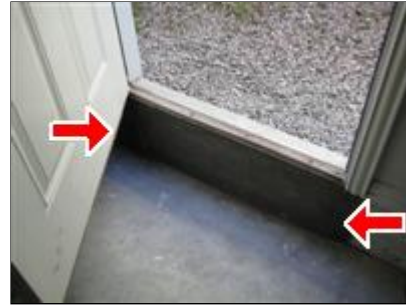
(1) A concrete riser appears to have been installed under the threshold at back door entry into garage. This may have been added in order to protect structure from water intrusion. A step should now be installed on both sides of the riser to avoid a tripping hazard. Recommend correction as necessary for safety.(Picture 1)(Picture 2)

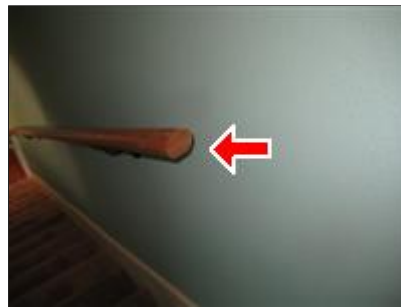
I. Picture 3

(2) Hand railing does not terminate properly against wall at the top of each staircase location. Purse straps are known to snag on hand railing(s) possible causing a tripping hazard. Recommend correction as necessary for safety.(Picture 3)

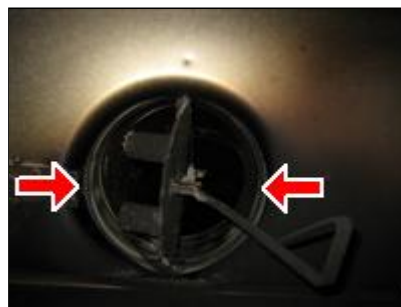
J. Picture 1

Fire-place and chimney-flue should be cleaned by a licensed chimney sweeper professional and evaluated for leakage as needed for safety before further usage.(Picture 1)

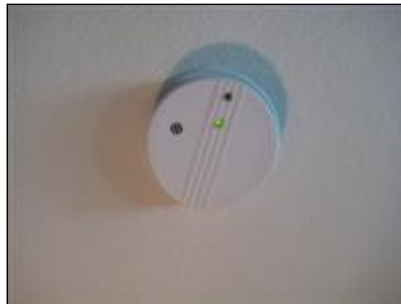
B. Picture 1

(1) The indoor smoke detector(s) should have new battery back-up installed and tested at common hallway to bedrooms and inside living areas as necessary for safety.(Picture 1)

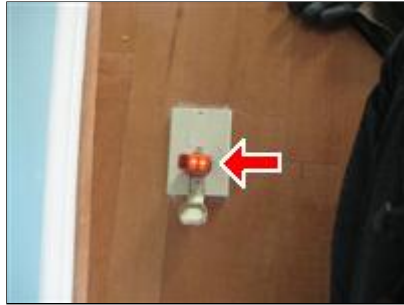
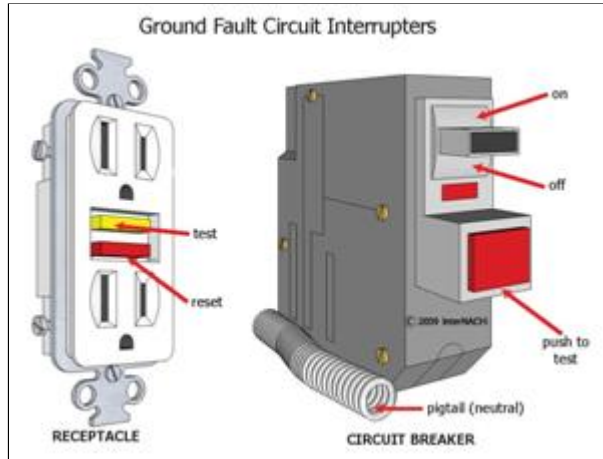
(2) No GFCI protected outlet at electrical floor plug at upstairs living room location(s).(Picture 2)(Picture 3)

B. Picture 2 Floor Receptacle

B. Picture 3 GFCI Receptacle

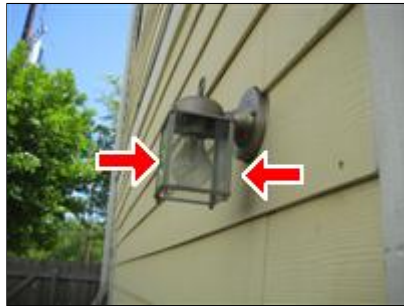
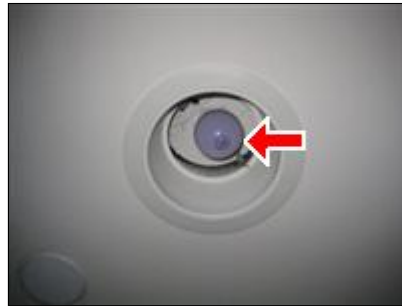
(3) Light fixtures and recessed lighting in various locations did not function when tested and/or may need light bulb replacement.(Picture 4)(Picture 5)

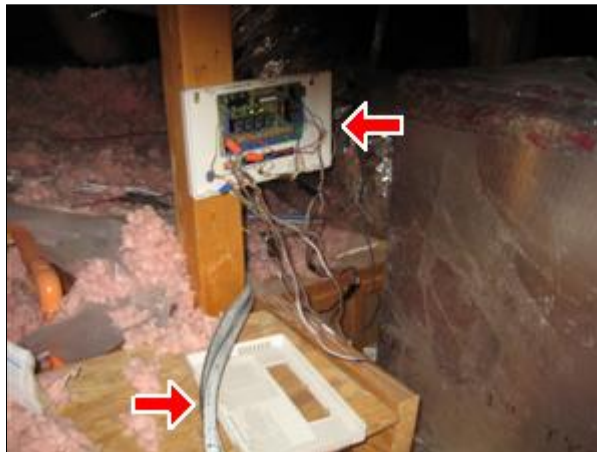
A. Picture 1

(2) Protective cover, that goes over circuitry-board and wire conductors to the changeover-unit, is detached and/or not properly in place inside attic space. The Changeover Controller allows you to operate two or more thermostats on one air handler (Furnace) from different locations inside the structure at different operating temperatures.(Picture 1)

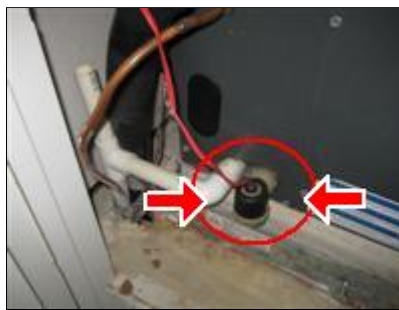
(2) **FYI (For your information):** No auxiliary drain line present at the evaporator coil location. But, a sensor has been installed, which is acceptable by standards, and should automatically shut the system down in case primary drain blockage occurs. This will protect your home from water intrusion while the cooling equipment is running. **Please keep in mind, this may, or may not have been required by standards when the air handler and evaporator coils were installed.**(Picture 2)

B. Picture 2 Water Overflow Sensor

**NOTE:** A secondary means to detect and/or direct water (Condensate) away from the structure is necessary and is needed in case primary drain line failure and/or back up was to occur from slime deposit.

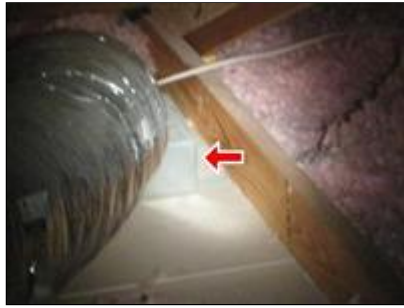
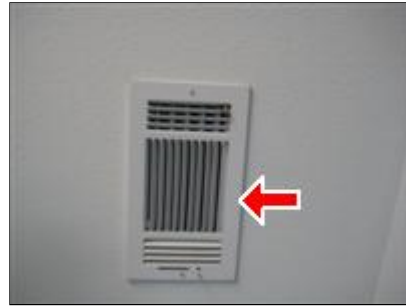
(1) Excessive vibration and noise coming from the vent register(s), when heating and cooling equipment are in use, at inside master bedroom location.(Picture 1)(Picture 2)

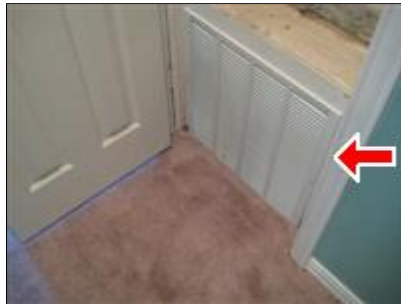
C. Picture 3

(2) Improper location and/or installation of a air-return register behind closet door. Air flow is reduced at this location when door is in the closed position. Recommend further evaluation(s) and/or service be performed by a licensed heating and cooling expert.(Picture 3)

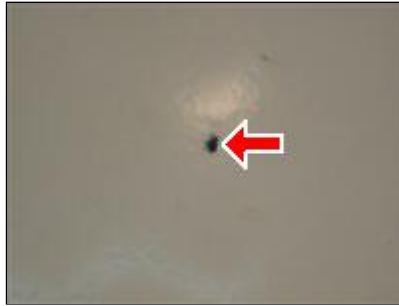
A. Picture 1

(1) Chips in tub porcelain coating in bathroom should be sealed to avoid rusting and deterioration.(Picture 1)

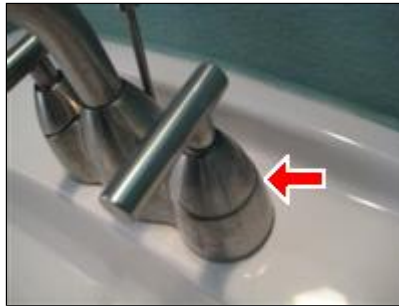
A. Picture 2

(2) The control knob(s) on faucet(s) are loose at various locations inside structure.(Picture 2)

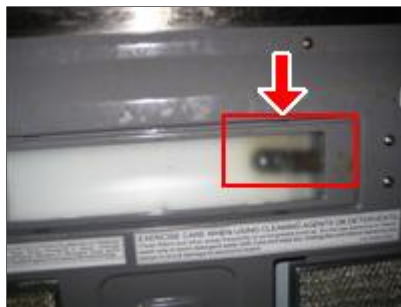
E. Picture 1

(1) Light not functioning at OTR (Over the range) microwave oven.(Picture 1)

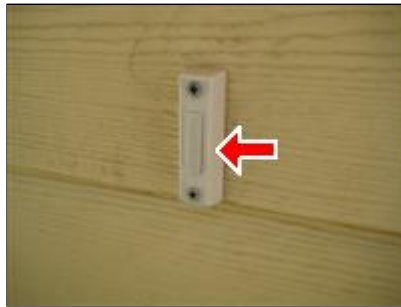
I. Picture 1

Doorbell has a short, sticking, and/or did not work properly unless pressed in a certain way.(Picture 1)

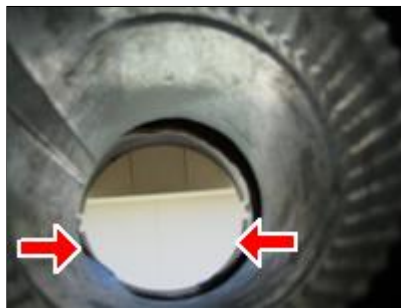
J. Picture 1

Dryer vent cover damaged and is missing flapper valve assembly and/or louvers at rear of structure. Opening in dryer venting can allow weather and birds to enter into structure if not corrected.
