# Inspection Report

**Property Address:**  
500 Sea Breeze Dr  
Dallas TX 75104

## PROPERTY INSPECTION REPORT

**By:** Kevan Brent Giles TREC # 7297 / Spec-Pro Inspection Services, LLC 6/18/2010  
 \_\_\_\_\_  
 (Name and License Number of Inspector) (Date)

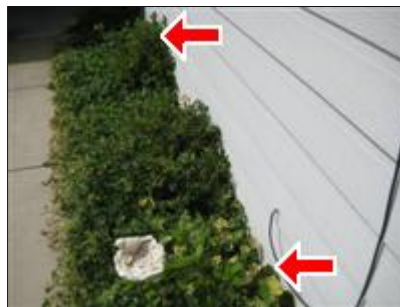
A. Picture 1

(1) Planting beds were installed against foundation wall at sides and rear of structure. Irrigating planting beds installed next to the structure may introduce excessive amounts of moisture to soil supporting the foundation. This condition can cause foundation and other structural damage from undermining, heaving or settling, depending on soil composition, moisture content and other conditions.(Picture 1)

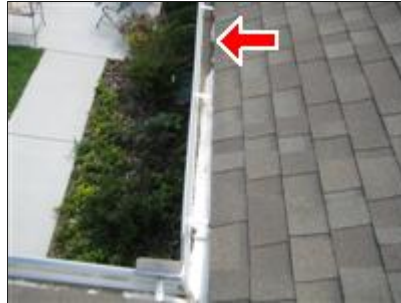
B. Picture 1

(1) The gutters have debris and roofing aggregate in areas around structure. The debris in gutters can also conceal rust, deterioration, or leaks that are not visible until cleaned, in order to find any conditions that may exist.(Picture 1)

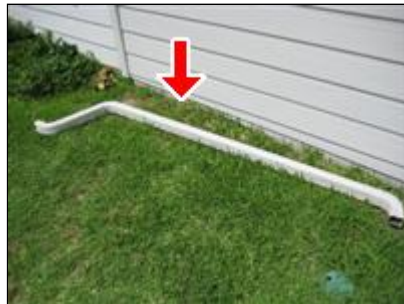
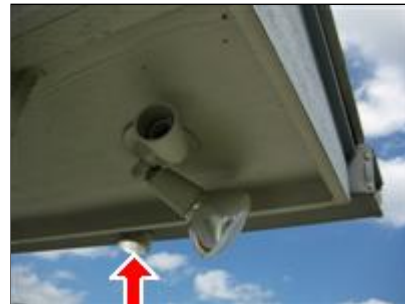
(2) Downspout attachment detached from rain gutter system at rear of structure. Recommend reattaching downspout drains as necessary for normal function.(Picture 2)(Picture 3)

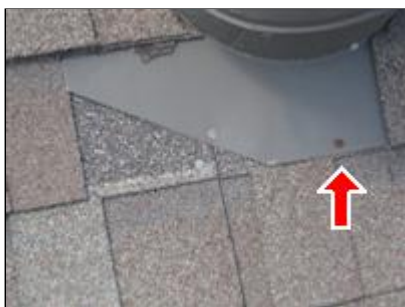
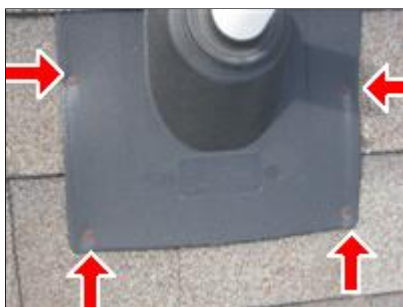
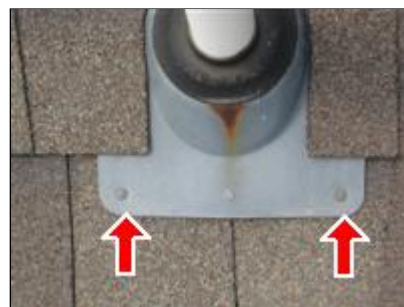
(1) Nail heads and/or fasteners exposed to weather at peak of roof and around vent flashings. Nail fasteners (Nail-heads) can erode away allowing flashing and/or shingles to come loose if siliconized roof caulking is not applied.(Picture 1)(Picture 2)(Picture 3)

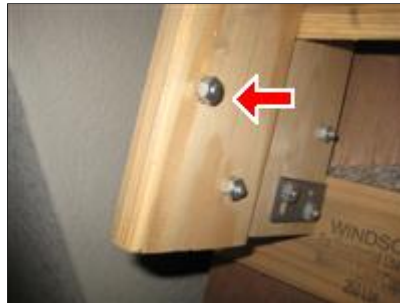
D. Picture 1

🏠 (1) The pull down stairs have loose hardware at room add-on location. Injury could result if not repaired.(Picture 1)

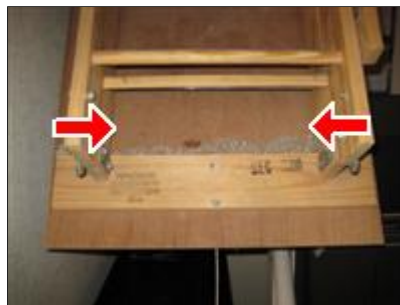
D. Picture 2

🏠 (2) Insulation missing at back of attic stair access inside room add-on location. Lack of insulation can affect efficiency of heating and cooling levels within the structure if not applied. Recommend adding insulation as necessary.(Picture 2)

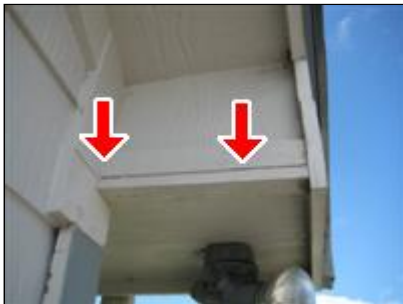
E. Picture 1 OPENINGS IN SOFFIT

**NOTE:** Open penetrations may allow moisture, insects, and/or pests to enter if not corrected and maintained as needed. Therefore, it is recommended sealing these areas as necessary to prevent further deterioration.

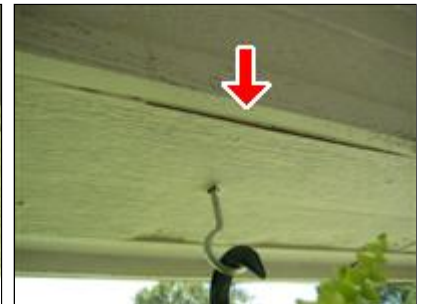
E. Picture 3 SEAM OPENINGS

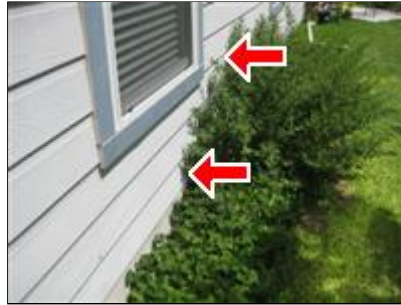
(2) Vegetation growing against the exterior walls may introduce pests and/or accelerate deterioration of the exterior wall covering by retaining moisture. Watering this vegetation will introduce moisture to the soil which may eventually reach the foundation. Moisture in soil supporting the foundation can affect the ability of the foundation to support the weight of the structure above and can cause damage from soil heaving or settling, depending on soil composition and other conditions.(Picture 4)

E. Picture 4 TRIM BACK 3-6"

**NOTE:** The Inspector recommends removal of the vegetation from exterior walls. Consider replacement with vegetation having low water requirements.

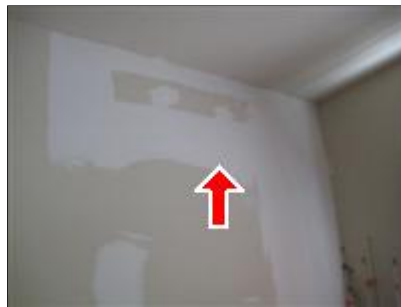
E. Picture 5 GUEST HOUSE  
BEDROOM

(3) Unfinished wall surfaces observed near ceiling inside front bedroom at guest house location. Previous drywall repairs can indicate possible water penetration(s) may have occurred and could return. Therefore, it is recommended to monitor affected areas and correct as necessary.(Picture 5)

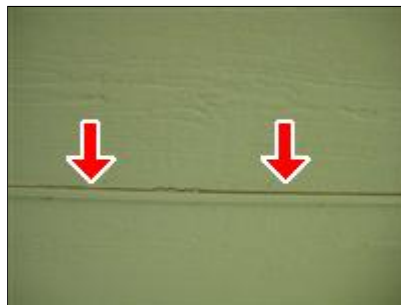
F. Picture 1

(2) Caulking separation in seams at panel board attachment points around outside of structure. Recommend adding siliconized caulking as necessary when openings occur.(Picture 1)

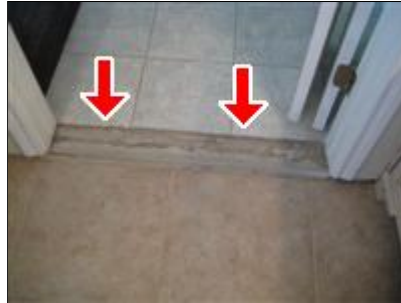
G. Picture 1

Doorway threshold is unfinished and baseboard materials missing at the master bathroom. This can be a tripping hazard if not corrected. Recommend installing the proper threshold, transitions, and baseboard materials as necessary for normal function.(Picture 1)

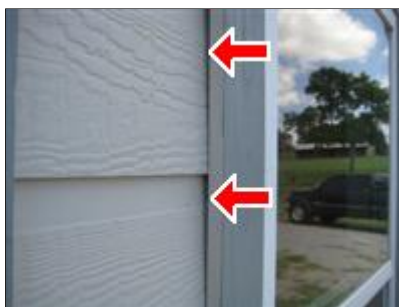
(2) Air leakage can develop around window components where insulation and caulking should be applied. Methods used to prevent air leakage at windows typically include installation of a foam sealant around windows. Confirmation of effective installation of windows against air leakage would require blower door testing or invasive methods, both of which are beyond the scope of the General Home Inspection. (Picture 1)

H. Picture 1 OPENINGS AROUND  
WINDOWS

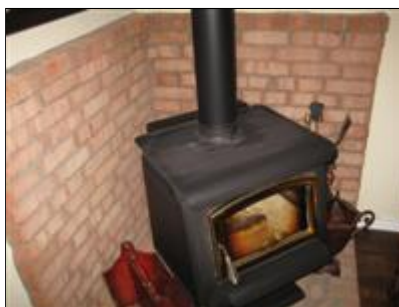
J. Picture 1

Wood stove and chimney-flue should be cleaned by a licensed chimney sweeper professional and evaluated for leakage as needed for safety before further usage.(Picture 1)

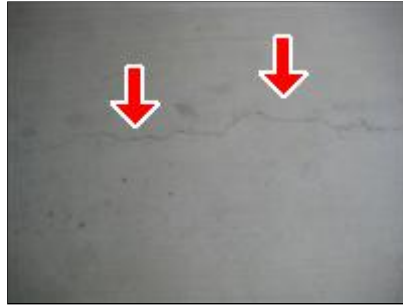
K. Picture 1

(1) Small stress cracks in concrete patios are common, due to lack of expansion joints and are considered cosmetic. The appearance of settlement cracks in concrete patio does not appear to affect foundation performance at time of this inspection.(Picture 1)

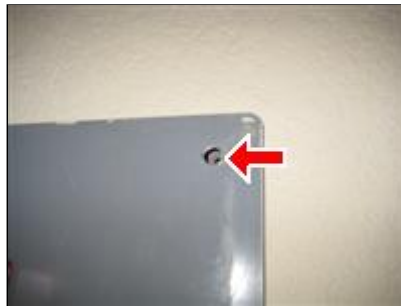
A. Picture 1

(3) One service panel screw missing in panel-box at room add-on location. Recommend installing a non-pointed screw approved for electrical use.(Picture 1)

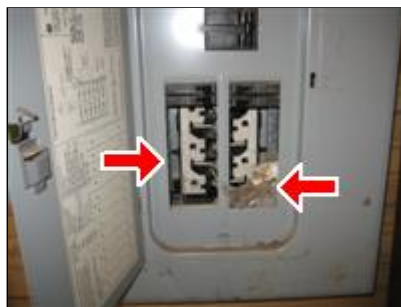
A. Picture 2 SUB-PANEL IN STABLES

(4) Combustible materials observed inside sub-panel box at horse stable should be removed. Plug covers or breakers missing over charged circuitry components can be hazardous if not corrected. Recommend service as necessary for safety.(Picture 2)

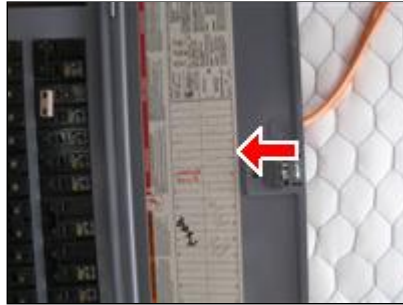
A. Picture 3

(5) Some labels are present, but are illegible or confusing at service panels inside garage and stable locations. Recommend correcting for safety reasons.(Picture 3)

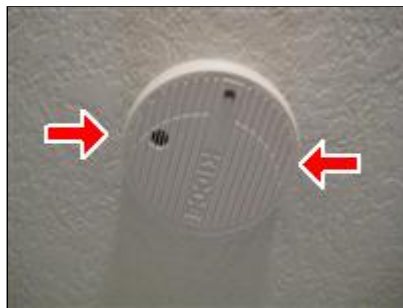
B. Picture 1

(1) The indoor smoke detector(s) should have new battery back-up installed and tested at common hallway to bedrooms and inside living areas as necessary for safety.(Picture 1)

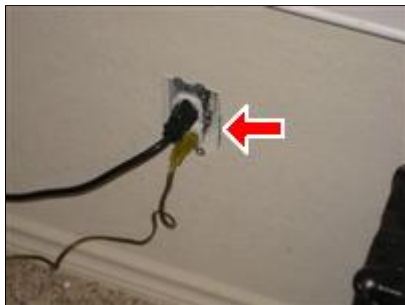
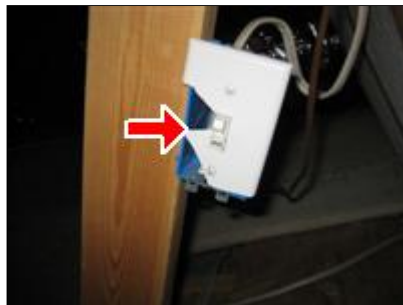
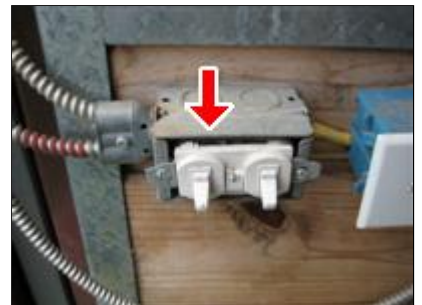
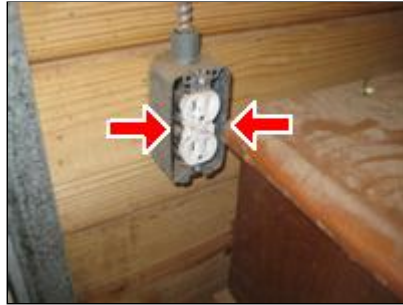
(2) Cover plates damaged and missing in various electrical outlet locations inside main structure and at metal garage. Shock or personal injury can occur if not corrected.(Picture 2)(Picture 3)(Picture 4)(Picture 5)

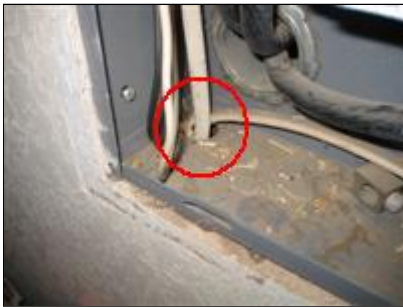
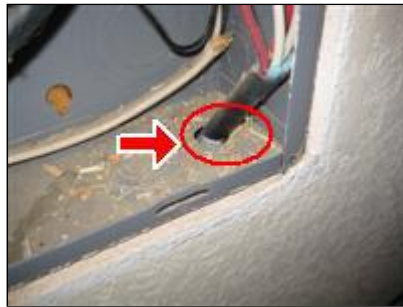
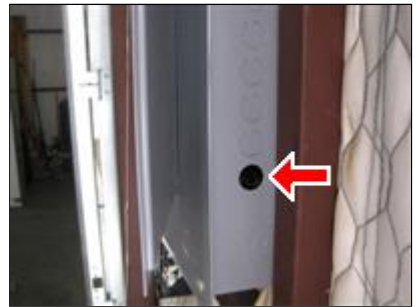
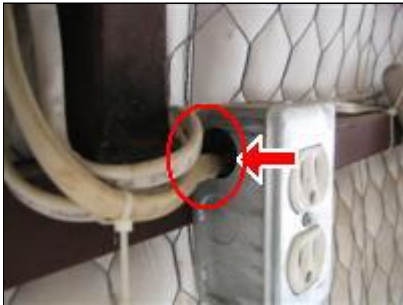
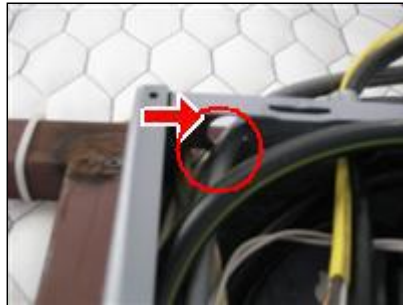
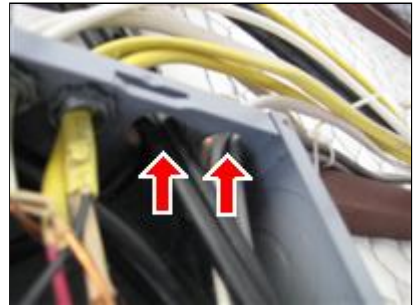
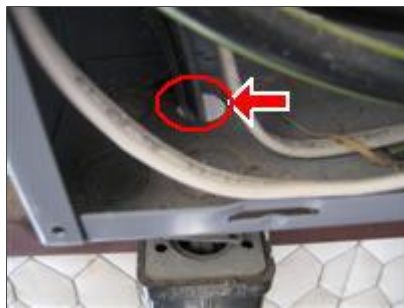
🏠 (3) Wire-stops (bushing protectors) missing around wire conductors, where sharp metal edges can cut into sheathing. Plug covers are also needed where openings into panel boxes are present. Electrical issues can be hazardous until corrected and should be performed by a certified electrical contractor.(Picture 6)(Picture 7)(Picture 8)(Picture 9)(Picture 10)(Picture 11)(Picture 12)(Picture 13)

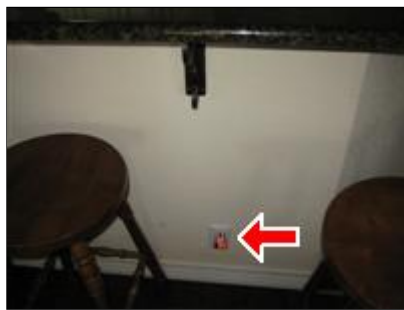
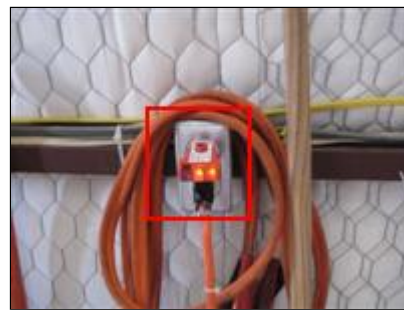
🏠 (4) Electrical outlets under bar and at metal garage are not GFCI (Ground Fault Circuit Interrupter) protected, but were operable at time of this inspection. Although, GFCI protection of electrical circuits may not have been required at the time in which this home was built, as general knowledge of safe building

B. Picture 14 NO GFCI UNDER BAR

B. Picture 15 NO GFCI AT METAL GARAGE

1. Replacing the current standard outlets with GFCI outlets.
2. Replacing the electrical circuit outlet located closest to the main electrical service panel with a GFCI outlet.
3. Replacing the breaker currently protecting the electrical circuit that contains these outlets with a GFCI breaker.

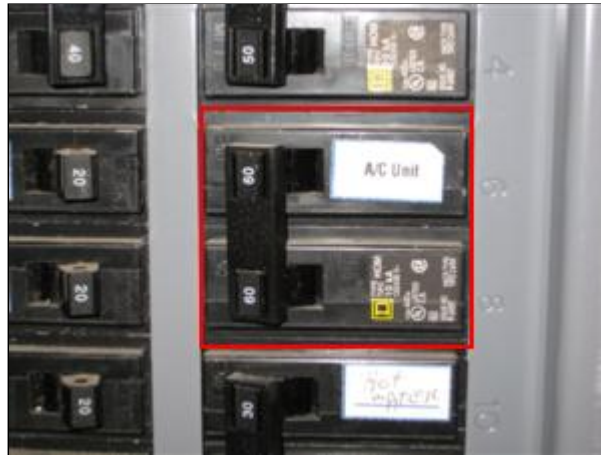
B. Picture 17 Breaker to Main Condensing-unit

(6) Breaker amperages to the main outdoor AC condensing unit was rated at 40 max. amps, according to manufacturer's requirements. The maximum amps at the breaker switch location inside structure was 60 amps. Max. Breaker Amperages at the AC condensing unit should match breaker amperage at the panel. Therefore, a higher rated breaker may not trip as needed in case of an emergency. Breaker replacement at the panel-box may be necessary and should be further evaluated and/or serviced by a qualified Heating and Cooling expert.(Picture 17)

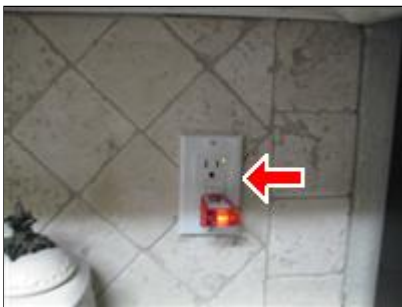
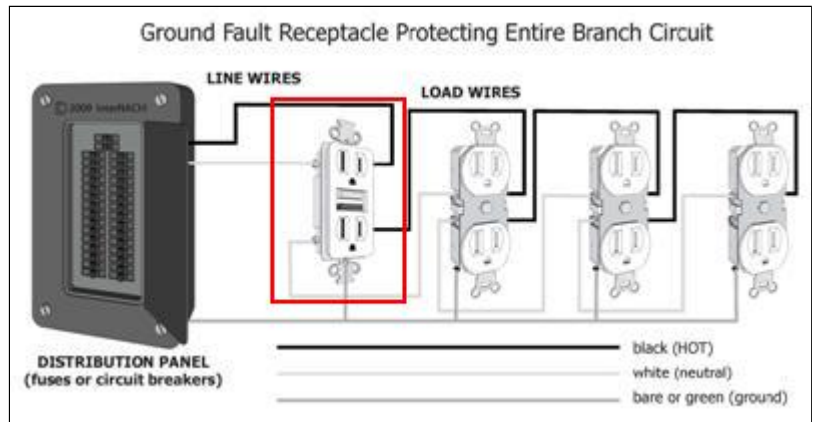
🏠 (7) Multiple GFCI (Ground Fault Circuit Interrupter) protected outlets applied on the same circuit at kitchen counter-top location. Electrical standards require only one GFCI outlet per "breaker-leg" is needed, and should be installed at the first receptacle from the service panel. Recommend replacing GFCI outlet with a standard receptacle as necessary for normal function.(Picture 18)(Picture 19)

B. Picture 18 OPEN GROUND

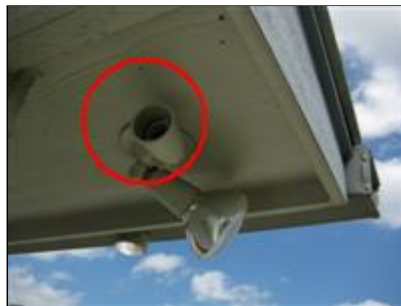
B. Picture 20 Outdoor lighting

🏠 (8) Light bulb needed or fixture repair at outdoor light fixture in rear of structure. Some outdoor lighting did not function when tested.(Picture 20)

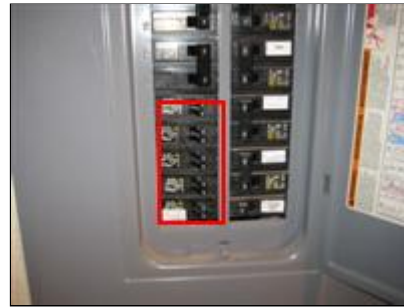
🏠 (9) The electrical system does not have AFCI (Arc-fault circuit interrupters) protection at required locations in bedrooms and living areas as necessary for safety. **This standard was not enforced and may not have been required when the home was constructed.** AFCI Protected outlets were effectively introduced January 1st, 2002, and was mandated by the NEC (National Electric Code) to protect 15 and 20 amp branch circuits servicing bedrooms in new construction. This is not a new home, so simply

B. Picture 22 Missing AFCI Breakers

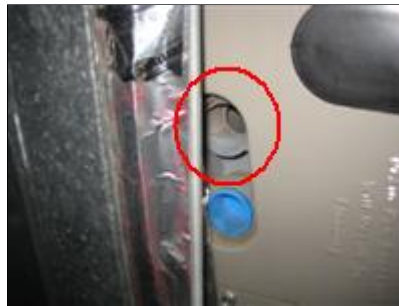
B. Picture 3

🏠 (2) Openings in the evaporator-coil cabinet at the air-handler unit will introduce conditioned air into the attic space and increase energy loss if not corrected. Recommend installing a plug drain cover as needed.(Picture 3)

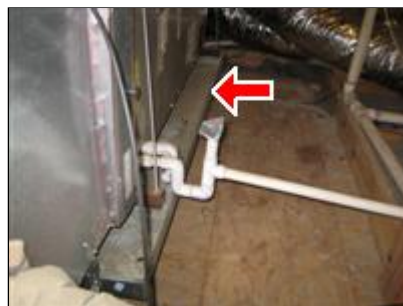
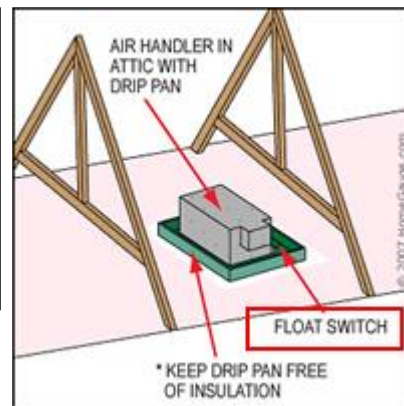
🏠 (3) Recommend installing a float valve device that signals the thermostat to shut off the system in case primary drain line blockage. This can protect the evaporator coils from damage and prolong life expectancy of the cooling system if correctly applied.(Picture 4)(Picture 5)

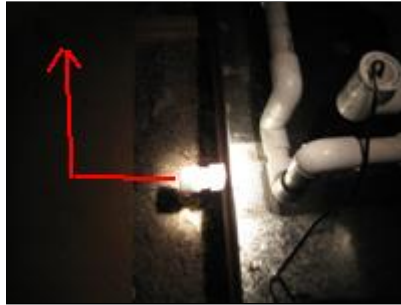
B. Picture 6 DRIP PAN AT SMALL AC

🏠 (4) 3/4 inch PVC drain line missing to drip pan supplying service to the room add-on location. Secondary drain source should be installed and plumbed to terminate at an outdoor soffit-panel location.(Picture 6)

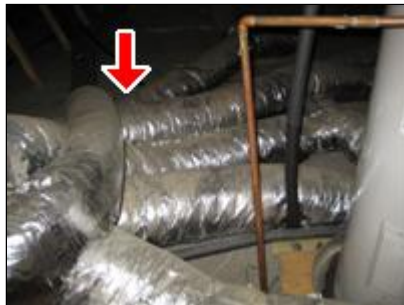
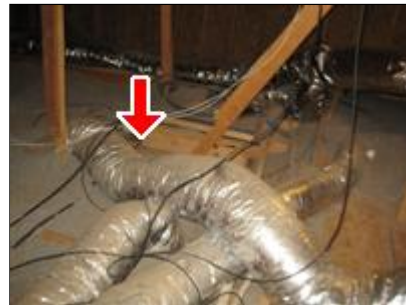
Flex ducting should be hung properly from rafters and not lay directly on ceiling joists. Noise vibration, eventual collapse and deterioration of the bottom sides of the ductwork can occur if not properly hung as suggested by today's standards and/or manufacturer's requirements.(Picture 1)(Picture 2)

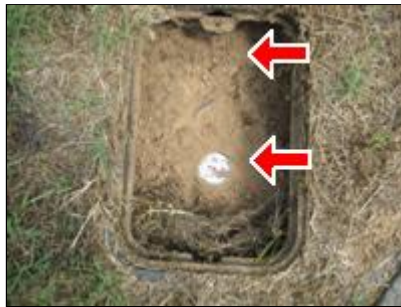
A. Picture 1

(1) Main water meter is buried under soil at street in front of property. Recommend removing soils as necessary for normal function.(Picture 1)

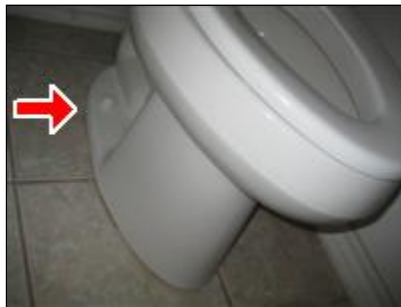
A. Picture 2

(2) The toilet is loose at floor at master bathroom location. Repairs may involve re-setting the toilet on a new wax seal. I recommend a qualified licensed plumber repair or correct as needed.(Picture 2)

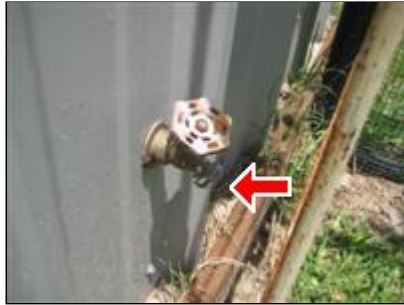
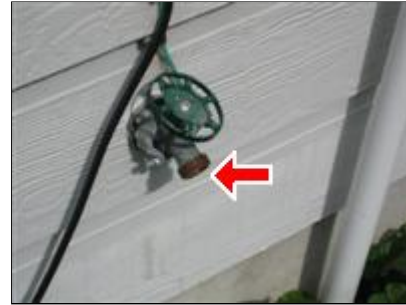
(3) Anti-siphoning devices or "vacuum-breakers" missing at both outdoor faucet locations in front and back of structure. Vacuum breakers installed on outdoor "hose-bibs" can protect clean potable water lines from contamination that can occur when fixtures are in use. Recommend repair or replace as necessary.(Picture 3)(Picture 4)

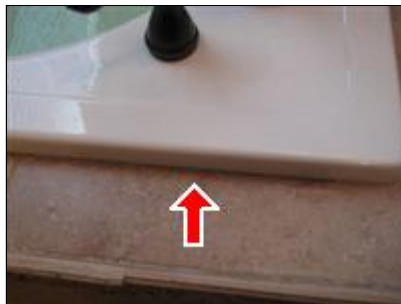
D. Picture 1

(1) Sealant should be applied around openings where water can enter behind the hydro-tub as necessary for normal function. Recommend applying siliconized caulking as needed.(Picture 1)

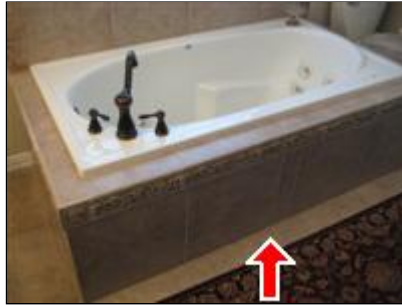
D. Picture 2

(2) Unable to access pump compartment to the hydro-tub without dismantling or prying open the panel cover. Since I am not allowed to dismantle panels and covers, knowing the condition of pump, related components, and proper grounding for safety is unknown at time of this inspection.(Picture 2)

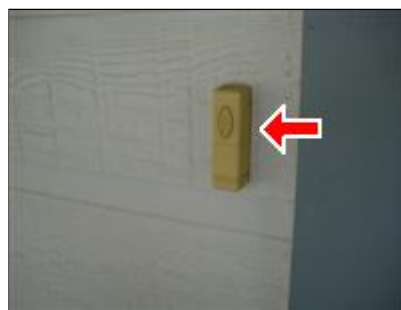
I. Picture 1

Door bell did not work when tested at front of home. Standards recommend that a hard-wired door bell type of system should be present, which are considered more reliable than battery operated units. (Picture 1)

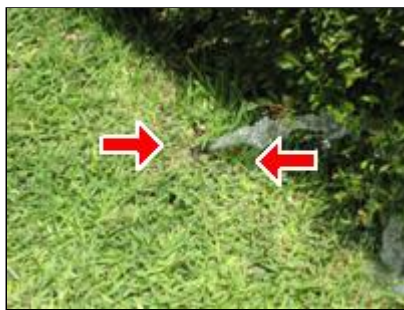
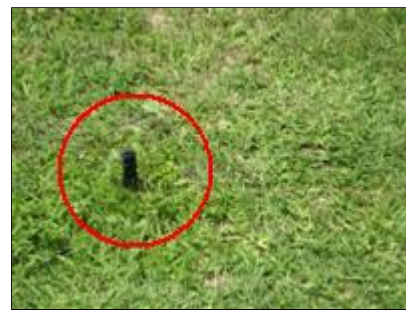
(2) Zones # 7 has 2 broken and/or damaged sprinkler heads at front of structure. Recommend service before further usage.(Picture 2)(Picture 3)

A. Picture 2 Zone# 7 damaged heads

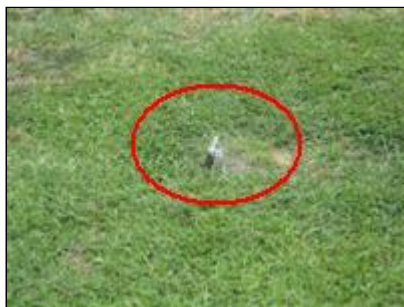
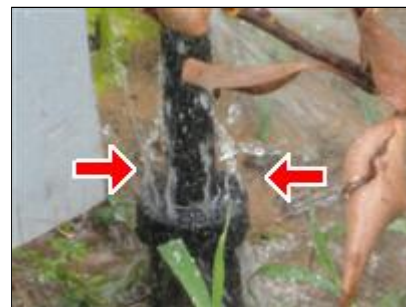
(3) Zones # 9 has 2 damaged sprinkler heads at rear of structure. Recommend service before further usage.(Picture 4)(Picture 5)

A. Picture 4 Zone# 9 damaged heads

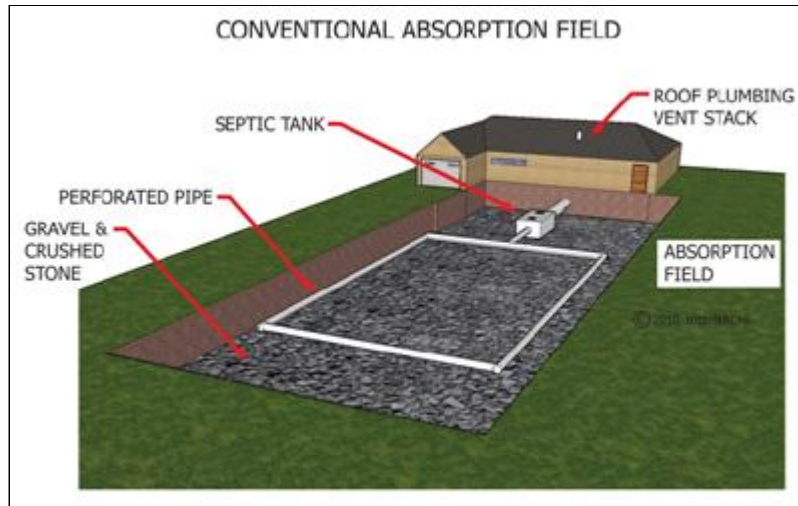
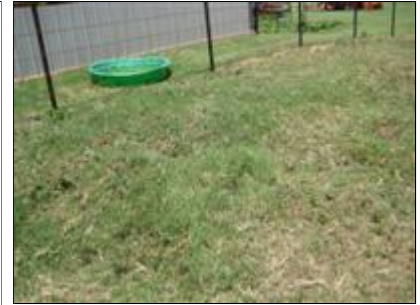
This inspection did not access the tank into the onsite septic system at rear of main structure. For a more detailed inspection, I recommend you contact a septic pumping company and have them clean it. At that time the system can be properly inspected for normal function. This may be especially important, if recorded documentation on the maintenance history of this system is not available.(Picture 1)(Picture 2)

G. Picture 2 COVERED BY SOIL
