# Inspection Report

**Property Address:**  
5006 Monticello Rd  
Dallas TX 75206

# PROPERTY INSPECTION REPORT

**By:** Kevan Brent Giles TREC # 7297 / Spec-Pro Inspection Services, LLC 6/9/2010  
\_\_\_\_\_  
(Name and License Number of Inspector) (Date)  
\_\_\_\_\_  
(Name, License Number and Signature of Sponsoring Inspector, if required)

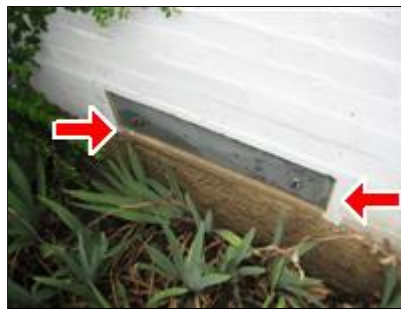
A. Picture 1

(1) Foundation vents are closed off at sides and front of home. Excessive moisture content and standing water under the structure is conducive if not properly ventilated. Not opening the vents when moisture is present could further harm your floor system or contribute to mold. I recommend opening the vents in the summer and closing some of them in the winter.(Picture 1)

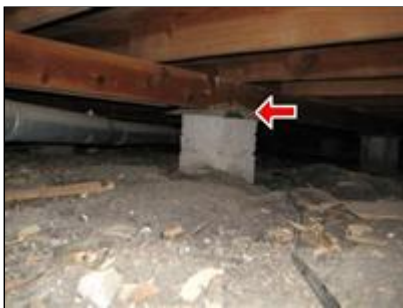
A. Picture 2

(2) Concrete pier(s) not aligned properly or are missing in areas under structure where sloping appears to have occurred. Areas of the structure may need more support and/or stability applied near front of the structure. Recommend further evaluation(s), service, or repair be performed by a qualified foundation expert.(Picture 2)(Picture 3)(Picture 4)

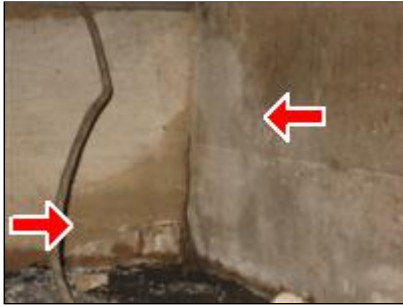
A. Picture 5

(3) White efflorescence (powder substance) on floor-joists and on inside foundation walls indicates moisture is, and/or was, in contact at various locations under structure. A moisture condition may still be present and may require additional ventilation. Efflorescence is found on many homes without water intrusion. But, should alert you to the possibilities of future steps that may be needed to correct this condition.(Picture 5)(Picture 6)(Picture 7)(Picture 8)

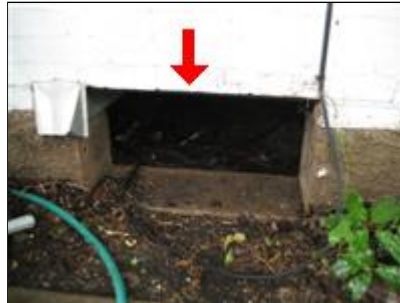
A. Picture 9

(4) Crawlspace entry at rear of structure needs to be closed off or have a door entry installed to keep out rodents and pest.(Picture 9)

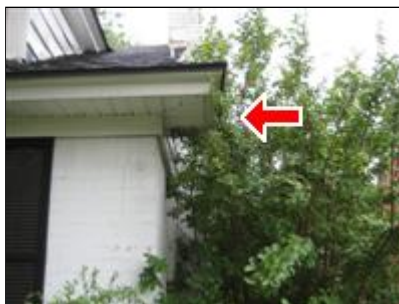
C. Picture 1

(1) The tree limbs and high foliage in direct contact with roof or hanging near roof should be trimmed. This is considered conducive to the structure until repaired.(Picture 1)

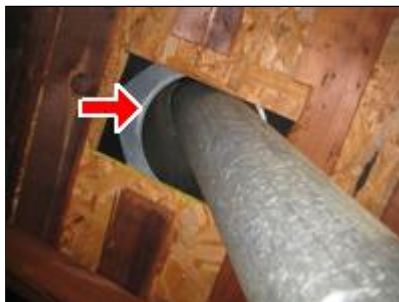
D. Picture 1

(1) Openings around vent stacks and piping inside attic space can allow water intrusion if not corrected. Recommend applying sealant as necessary around vent protrusions around the ceiling inside attic space.(Picture 1)

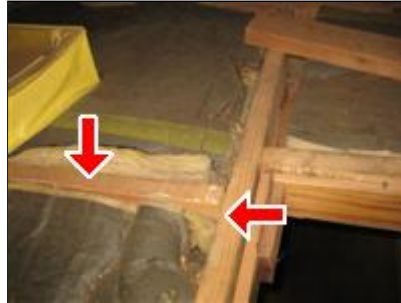
D. Picture 2

(2) Insufficient amount of insulation observed inside attic space, with less than 6 inches at some locations. Recommend adding insulation of a minimum of 8-10 inches or as necessary for normal function.(Picture 2)

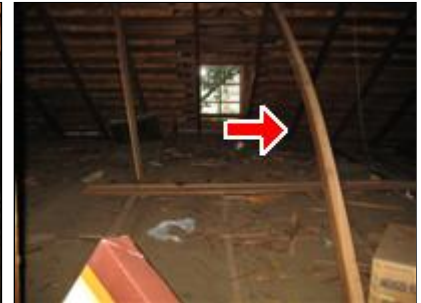
(3) Additional rafter supports are needed in ceiling structure inside attic space. Existing rafter supports are weak and limited in areas. By adding purlins and supports can increase the stability in the roof structure if applied. Recommend further evaluation(s) and/or service be performed by a qualified expert.(Picture 3)(Picture 4)(Picture 5)

D. Picture 5 WEAK / UNSTABLE SUPPORTS

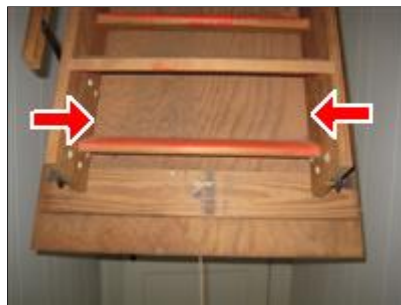
D. Picture 6

(4) **FYI (For your information):** Insulation missing at back of attic stair access. Energy loss can occur from this location that can affect heating and cooling efficiency levels within the structure if not corrected. Recommend adding insulation as necessary for efficiency reasons.(Picture 6)

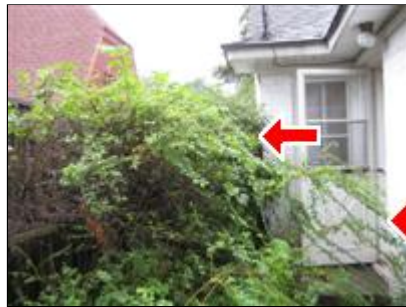
E. Picture 1

(1) Vegetation growing against the exterior walls may introduce pests and/or accelerate deterioration of the exterior wall covering by retaining moisture. Watering this vegetation will introduce moisture to the soil which may eventually reach the foundation. Moisture in soil supporting the foundation can affect the ability of the foundation to support the weight of the structure above and can cause damage from soil heaving or settling, depending on soil composition and other conditions.(Picture 1)(Picture 2)

**NOTE:** The Inspector recommends removal of the vegetation from exterior walls. Consider replacement with vegetation having low water requirements.

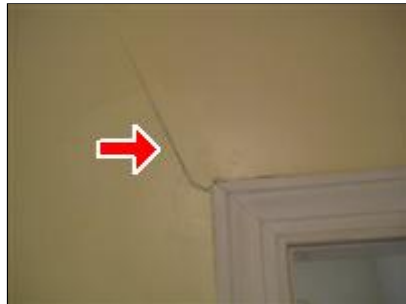
E. Picture 3

(2) Stress cracks and/or open penetrations in drywall above doors and along brick veneer wall is usually an indication that significant settling and/or shifting has occurred. The appearance of settlement crack(s) are common and can be corrected if necessary.(Picture 3)(Picture 4)

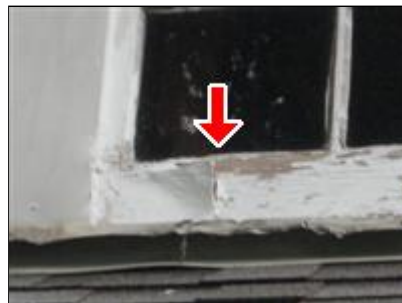
E. Picture 5

(3) Paint surfaces deteriorated on front dormers, with wood-rot in horizontal fascia boards under metal-clad siding at front, sides, and back of structure. Further deterioration can occur if not corrected. Properly installed rain gutter system can also protect the structure from exposure to water penetrations if applied.(Picture 5)

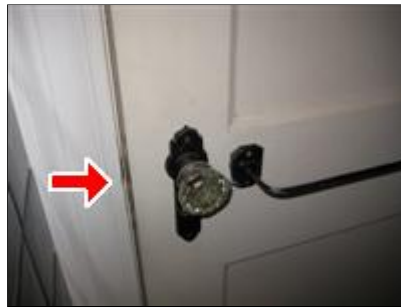
G. Picture 1

Door assembly will not latch closed under normal conditions and there is no privacy lock to the hallway bathroom inside structure.(Picture 1)

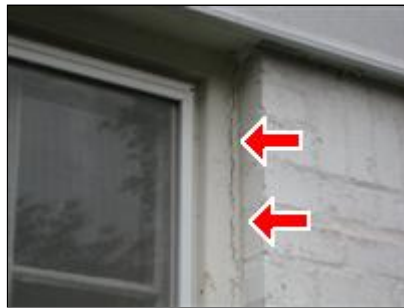
H. Picture 1

(1) Openings in caulking observed around widows at front of structure. Sealant eventually dries, shrinks, and cracks commonly develop. Siliconized caulking applied around exterior facing windows is necessary to protect structure from water and/or insect intrusion and should be maintained as openings re-occur.(Picture 1)(Picture 2)

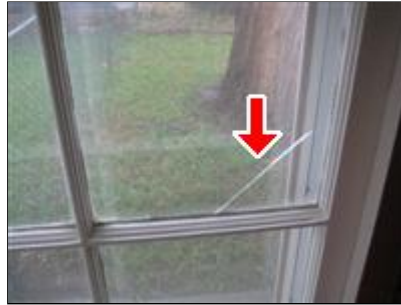
H. Picture 3

(2) There are cracked glass in some window panes throughout the home.(Picture 3)

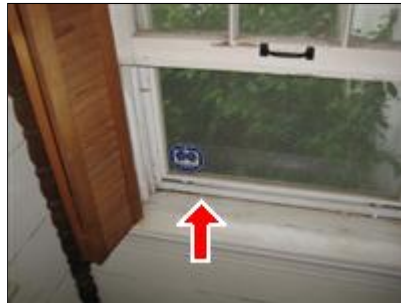
H. Picture 4

(3) Storm windows installed over existing windows are considered a safety hazard, if they do not provide adequate egress in the event of a fire.(Picture 4)

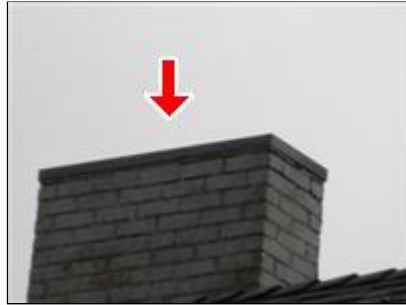
J. Picture 1

(1) Metal rain cap on chimney crown is missing. Instead, a metal screen plate has been installed over the opening and has become detached. Without a rain cap, water can enter into chimney flue and inside the structure if not corrected.(Picture 1)(Picture 2)

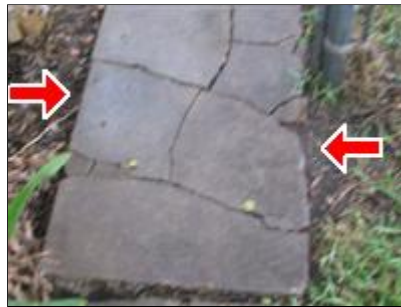
K. Picture 1

Crack(s) in sidewalk at front and back of structure is considered a trip hazard until corrected. Recommend repair or replace as necessary.(Picture 1)

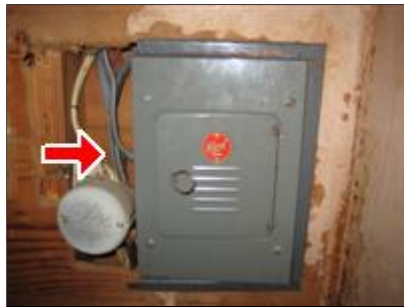
(2) You have a Federal Pacific panel which is legal, but there is a possibility that the circuit breakers may not trip when shorted possibly causing an electrical hazard. Opinions by licensed electrical contractors on this panel varies between safe and unsafe. I recommend you consult a licensed electrical contractor for an opinion and correct if necessary.(Picture 2)(Picture 3)

A. Picture 2 FEDERAL PACIFIC PANEL

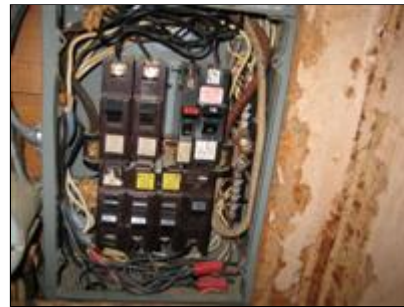
A. Picture 3 INSIDE CLOTHES CLOSET

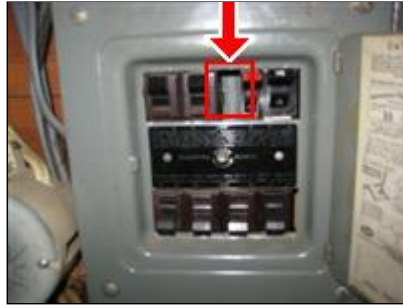
A. Picture 4

(3) The main panel box is located inside a clothes closet which is not considered safe and is not allowed by today's electrical standards. Plug covering and/or breaker missing at service panel inside of structure. Openings into the electrical panel box should always be covered as necessary for safety.(Picture 4)

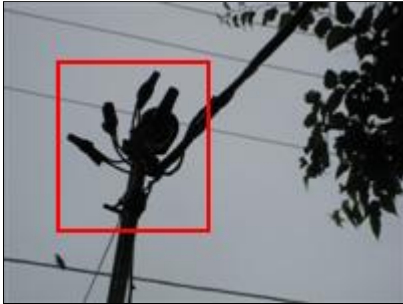
A. Picture 5

🏠 (4) Improperly installed and/or exposed wire conductors from the house to the un-attached garage. Wire connections that do not terminate inside a junction box is considered a hazard until corrected. Outdoor rated wiring should also run through EMT (Electrical Metallic Tubing) approved for outdoor usage and be installed underground in accordance to electrical standards. Recommend service as necessary by a qualified electrical expert.(Picture 5)(Picture 6)(Picture 7)

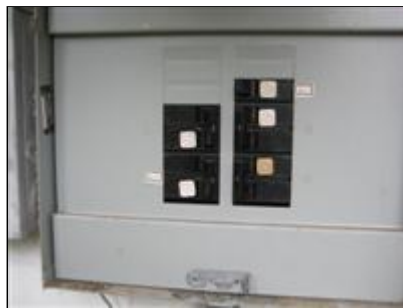
A. Picture 8

🏠 (5) Breakers are not clearly labeled as needed for safety at main panel-box inside clothes closet and at outdoor sub-panel location. Some labels are present, but are illegible or confusing. I recommend correcting for safety reasons.(Picture 8)

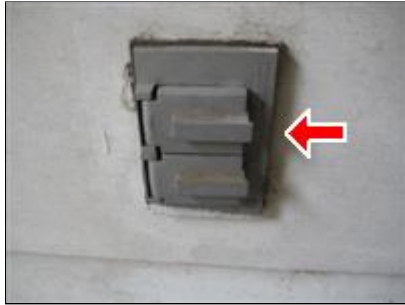
(2) Exterior electrical outlets were operable at the time of the inspection but had no Ground Fault Circuit Interrupter (GFCI) protection. Although, GFCI protection of exterior circuits may not have been required at the time in which this home was built, as general knowledge of safe building practices has improved with the passage of time, building standards have changed to reflect current understanding. The Inspector recommends updating the existing exterior electrical circuits to include GFCI protection.(Picture 1)(Picture 2)(Picture 3)(Picture 4)(Picture 5)

B. Picture 1 NO GFCI OUTDOORS

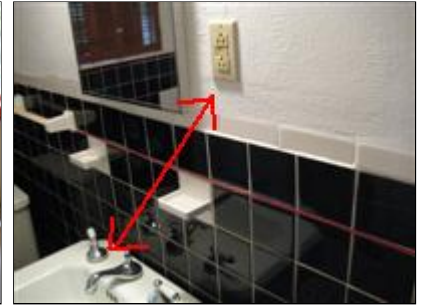
B. Picture 3 GFCI NON-FUNCTIONING

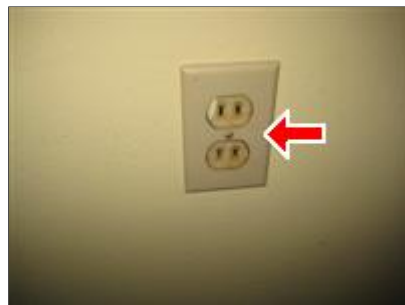
B. Picture 9

(4) Outlets at various locations inside structure are "two-wire" and are not grounded. Two wire outlets are acceptable due to age of structure, but some appliances cannot be plugged into outlets or will not work without a ground. Recommend repair or replace as necessary.(Picture 9)(Picture 10)

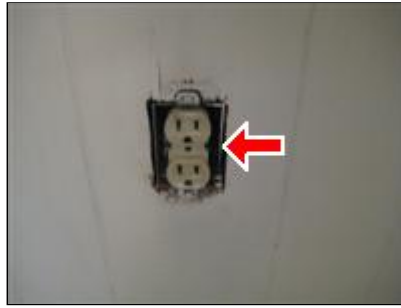
B. Picture 11

(5) Cover plate missing over electrical outlets in dinning room location. Shock or personal injury can occur if not corrected.(Picture 11)

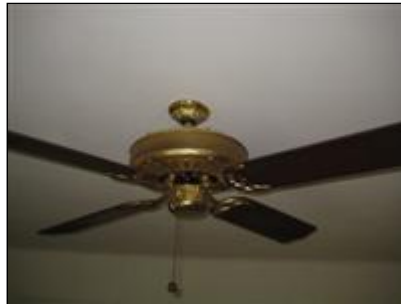
B. Picture 12

(6) Ceiling fan did not function when tested at various locations inside structure. Ceiling fan replacement may be necessary.(Picture 12)

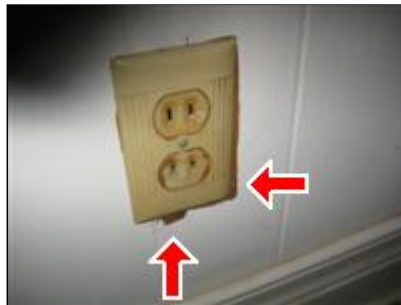
B. Picture 13

(7) Electrical outlet boxes are filled with insulation foam which is considered a fire hazard and should be removed or corrected as necessary for safety.(Picture 13)

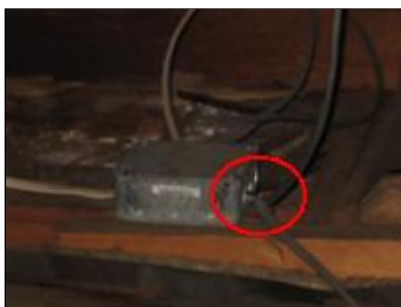
B. Picture 14

(8) Bushing protection or "wire-stops" missing around all accessible metal junction boxes inside attic, crawlspace, and laundry room locations. Damage to sheathing and wire conductors can occur if not corrected. Recommend repair or replace as necessary. Electrical issues are hazardous until repaired and should be performed by a certified electrical contractor.(Picture 14)

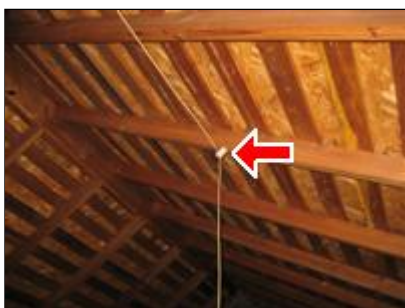
B. Picture 15

(9) The attic is poorly insulated and "Knob and Tube" wiring is present. As a safety rule Knob and Tube wiring should never have insulation covering this wire or over heating can occur. If new insulation is added, an electrical contractor should first replace knob and tubing wires with updated wiring.(Picture 15)(Picture 16)

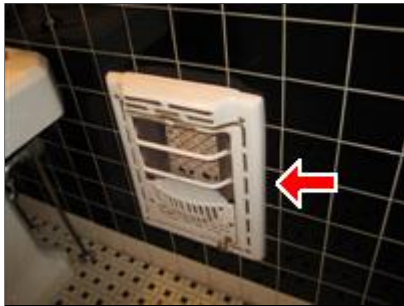
🏠 (1) Wall heaters did not function when tested at time of inspection, due to no gas utilities. Gas fired wall heaters are dis-allowed by today's standards and are considered a fire hazard. Recommend capping off and/or removing these units as necessary for safety.(Picture 1)(Picture 2)(Picture 3)(Picture 4)

A. Picture 1 GAS WALL HEATER

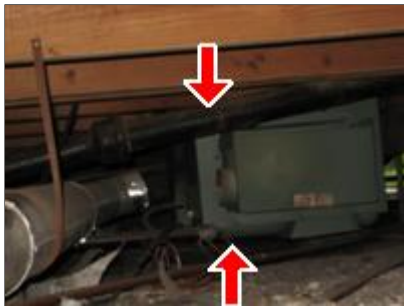
🏠 (2) Old heating equipment should be updated, serviced, and/or removed as necessary for normal function. Gas fired wall heaters and floor furnaces are no longer allowed by today's standards and should be thoroughly evaluated or serviced as necessary before further usage by a heating and cooling expert.(Picture 5)(Picture 6)(Picture 7)(Picture 8)

A. Picture 5 FLOOR FURNACE

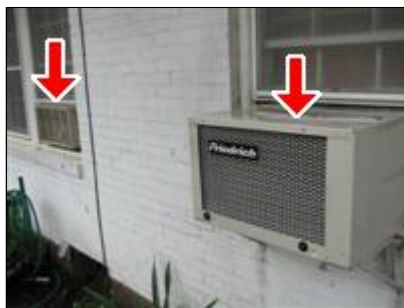
B. Picture 1

The air conditioning equipment is 3 window units which is considered a package type of system that is limited to the room(s) it is located. This home is not equipped with central cooling type of system. Recommend upgrade as needed to a split-system type of Air Conditioning / Heating System, which can be more efficient if applied.(Picture 1)(Picture 2)

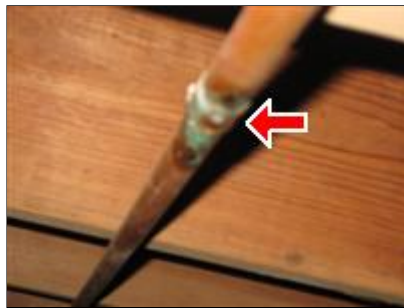
A. Picture 1

(1) Insulation wraps and/or sleeves should be present around copper tubing to water lines under structure. Further erosion can occur if not corrected.(Picture 1)(Picture 2)

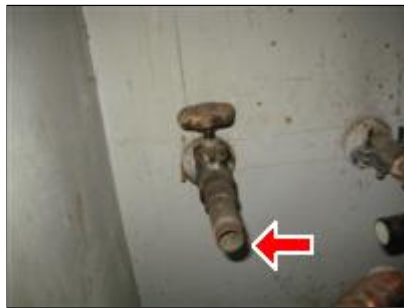
A. Picture 3

(2) Non-dedicated and/or abandoned water lines observed at various locations inside and around structure. Old plumbing debris should be removed as necessary.(Picture 3)(Picture 4)

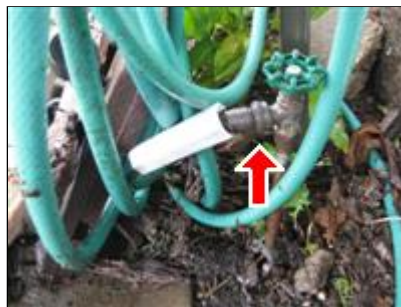
A. Picture 5

(3) Anti-siphoning devices or "vacuum-breakers" missing at both outdoor faucet locations in front and back of structure. Vacuum breakers installed on outdoor "hose-bibs" can protect clean potable water lines from contamination that can occur when fixtures are in use. Recommend repair or replace as necessary.(Picture 5)

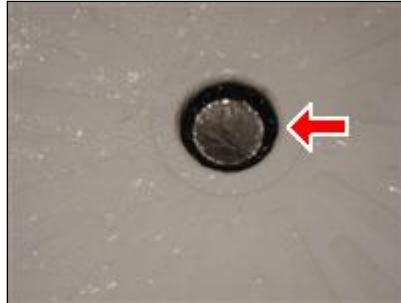
B. Picture 1

(1) Screened drain cover missing on shower pan at hallway bathroom inside structure.(Picture 1)

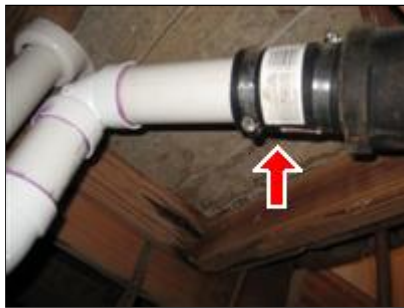
B. Picture 2

(2) Rubber union connectors are considered a temporary fix that can eventually leak over time at areas under structure. A more permanent connection device should be applied in areas where rubber unions are present.(Picture 2)(Picture 3)(Picture 4)(Picture 5)(Picture 6)

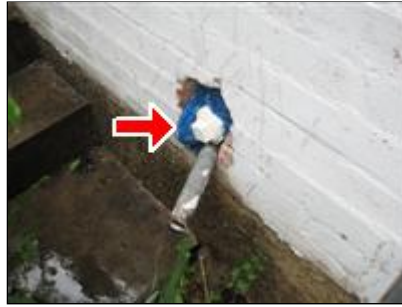
B. Picture 7

(3) Plumbing clean-out is loose in wall and does not appear to be properly installed at right side (Facing front) of structure. Galvanized steel piping protruding out around clean-out can also be a hazard if not removed. I am unable to determine exact purpose for this application and should be further evaluated and corrected as necessary by a qualified plumbing expert.(Picture 7)

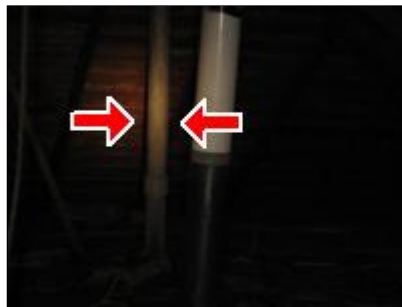
B. Picture 8

(4) Observed asbestos B-vent piping attached to the water heater inside attic space. Asbestos material is not a hazard until disturbed and/or moved. But, there is still a risk to consider having this kind of material around and should be corrected as necessary for safety.(Picture 8)

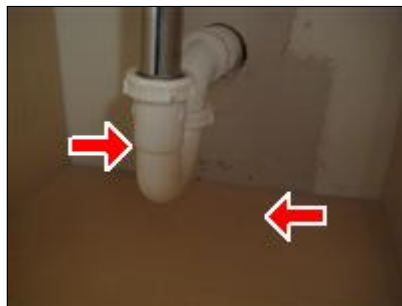
B. Picture 9

(5) Water leakage from drain piping under sink at 1/2 bath location. Further water damage can occur if not corrected.(Picture 9)

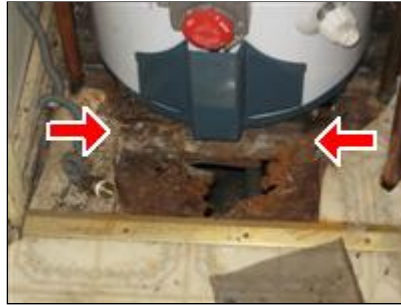
C. Picture 1

(1) Wood supporting water heater is badly deteriorated to the point that the unit could fall through the floor. Therefore, causing significant damage and possible gas leakage if not corrected.(Picture 1)

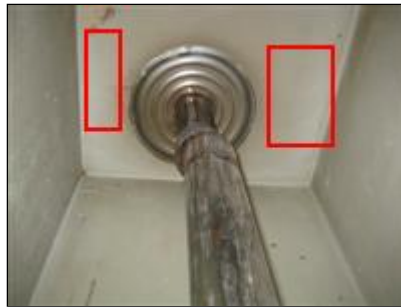
C. Picture 2

(2) Additional draft ventilation is needed inside closet space where gas water heater is located to vent out harmful gas fumes that can collect inside the structure. Dilution air vents and ducting are needed around the burner-plate at base of water heater, in addition to help draw out harmful carbon monoxide gas build-up and should be present as necessary for safety.(Picture 2)

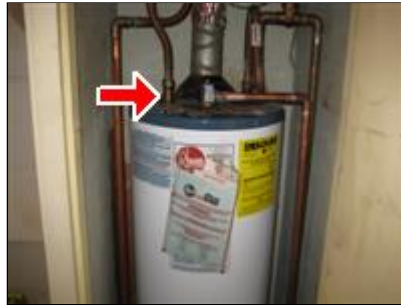
C. Picture 3

(3) Corrosion around fitting connections at top of water heater can eventually fail and develop leaks if not corrected. Water heater may need replacement.(Picture 3)

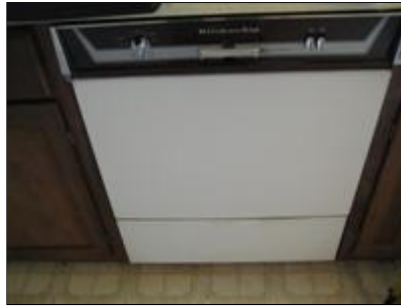
A. Picture 1

(1) The dishwasher is old and did not function at time of this inspection. Therefore, dishwasher did not complete normal cycle, did not fill with water, and is coated with mineral deposits. Recommend repair or replacement as necessary.(Picture 1)

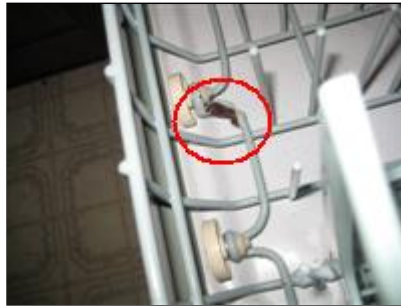
A. Picture 2

(2) Dishwasher racks are rusted at areas inside unit. Rusty areas can affect cleaning capabilities if not corrected.(Picture 2)

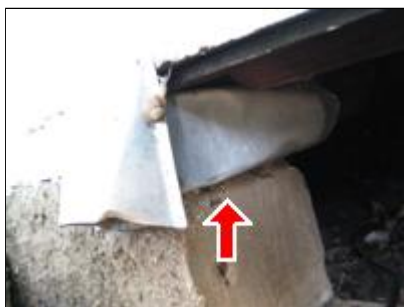
J. Picture 1

Dryer vent damaged and is poorly or improperly installed around crawlspace access location at rear of structure.(Picture 1)(Picture 2)

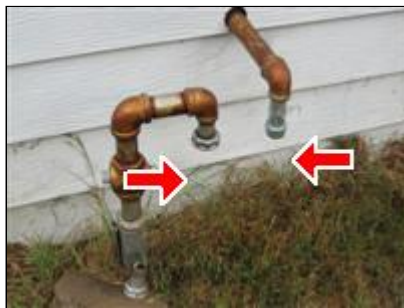
E. Picture 1

Gas meter has been removed and the lines are capped at various locations around structure. Observed that the gas lines were also being pressure tested at time of inspection. Therefore, gas fired appliances and heating equipment inside structure could not be properly checked for normal function.(Picture 1)(Picture 2)
