# Inspection Report

## Condominium Sample Report

**Property Address:**  
2600 Stutz Rd #200  
Dallas TX 75235

# PROPERTY INSPECTION REPORT

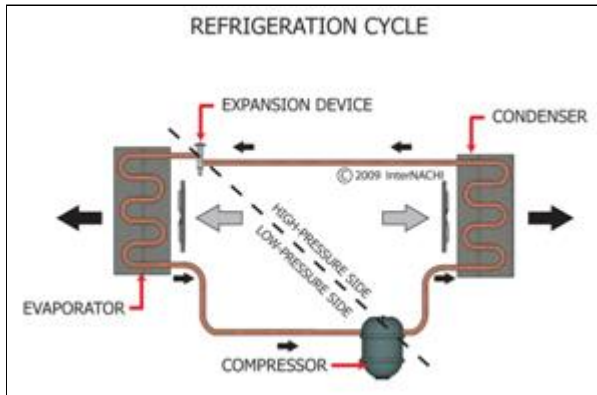
B. Picture 1 Cooling Cycle Diagram

The ambient air test was performed by using thermometers on the air handler portion of Air conditioner units, to determine if the difference in temperatures of the supply and return air are between 14 degrees and 22 degrees which indicates that the units are cooling as intended fro normal operation.

x Unit #1 - Supply Air Temp: 58-63 Return Air Temp: 71-74 Temp. Differential: 16 Degrees F **(Normal)**
