# Inspection Report

**Property Address:**  
500 Sea Breeze Dr  
Dallas TX 75104

## PROPERTY INSPECTION REPORT

**By:** Kevan Brent Giles TREC # 7297 / Spec-Pro Inspection Services, LLC 6/18/2010  
 \_\_\_\_\_  
 (Name and License Number of Inspector) (Date)

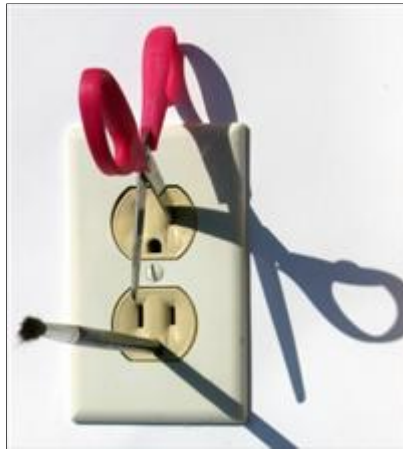
B. Picture 21 Why AFCI? Safety!

consider the benefits of installing them as necessary for safety when children are present.(Picture 21)(Picture 22)

**NOTE:** AFCI breakers are now required to be installed in all living and bedroom circuits. These safety devices are intended to detect the kinds of electrical arcs that can cause fire and/or personal injury. An AFCI breaker is designed to trip when it detects a dangerous arc, either in the house wiring, when hot's and neutrals are accidentally crossed, defects in an extension cord, and/or appliance.

(9) The electrical system does not have AFCI (Arc-fault circuit interrupters) protection at required locations in bedrooms and living areas as necessary for safety. **This standard was *not* enforced and may *not* have been required when the home was constructed.** AFCI Protected outlets were effectively introduced January 1st, 2002, and was mandated by the NEC (National Electric Code) to protect 15 and 20 amp branch circuits servicing bedrooms in new construction. This is not a new home, so simply consider the benefits of installing them as necessary for safety when children are present.(Picture 21)(Picture 22)

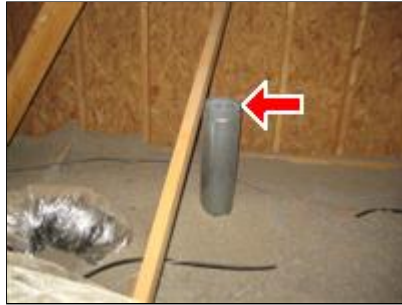
G. Picture 1

The Exhaust Fan(s) are plumbed to vent inside attic space from all downstairs bathroom locations. Many homes have their vent pipes poised to vent into attic space, which may have been acceptable by standards when this home was constructed. Therefore, It is up to you to determine weather or not this is a concern, or needs further consideration from a general contractor.(Picture 1)(Picture 2)

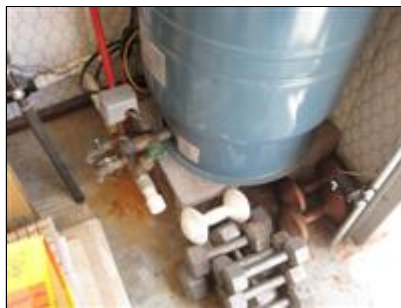
F. Picture 1

(1) Well pump, pressure tank, and related components appear to be properly installed to manufacturer's requirements and is performing the functional purpose intended at time of this inspection.(Picture 1)
