# Inspection Report

**Property Address:**  
5006 Monticello Rd  
Dallas TX 75206

# PROPERTY INSPECTION REPORT

**By:** Kevan Brent Giles TREC # 7297 / Spec-Pro Inspection Services, LLC 6/9/2010  
\_\_\_\_\_  
(Name and License Number of Inspector) (Date)  
\_\_\_\_\_  
(Name, License Number and Signature of Sponsoring Inspector, if required)

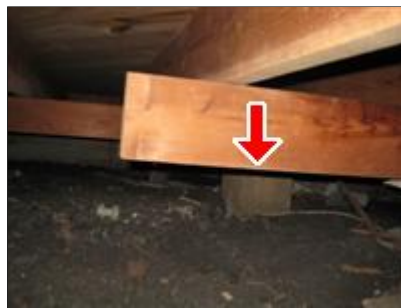
A. Picture 3

(2) Concrete pier(s) not aligned properly or are missing in areas under structure where sloping appears to have occurred. Areas of the structure may need more support and/or stability applied near front of the structure. Recommend further evaluation(s), service, or repair be performed by a qualified foundation expert.(Picture 2)(Picture 3)(Picture 4)

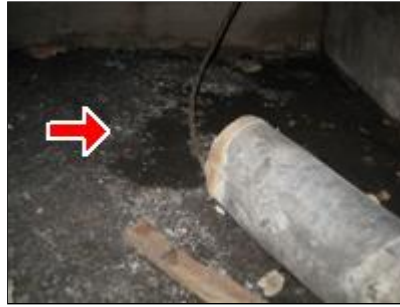
A. Picture 6

(3) White efflorescence (powder substance) on floor-joists and on inside foundation walls indicates moisture is, and/or was, in contact at various locations under structure. A moisture condition may still be present and may require additional ventilation. Efflorescence is found on many homes without water intrusion. But, should alert you to the possibilities of future steps that may be needed to correct this condition.(Picture 5)(Picture 6)(Picture 7)(Picture 8)

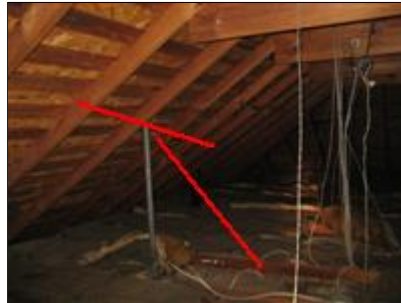
D. Picture 4 LACK OF RAFTER SUPPORTS

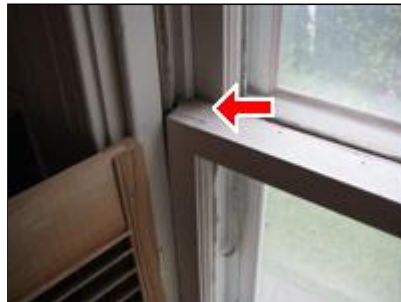
H. Picture 5

(4) Some windows are difficult to open or close and appear to be painted shut in some locations at time of inspection.(Picture 5)

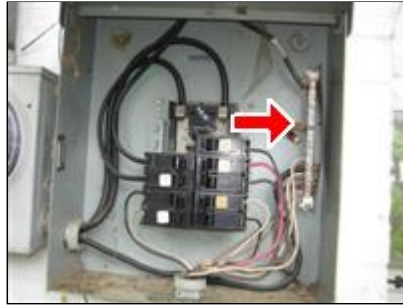
🏠 (6) Grounds and neutrals are wired onto the same bus bar at outdoor sub-panel box location. This kind of application can affect normal function of the electrical system and should be corrected as necessary for safety.(Picture 9)

A. Picture 9 SUB-PANEL  
OUTSIDE

(6) Grounds and neutrals are wired onto the same bus bar at outdoor sub-panel box location. This kind of application can affect normal function of the electrical system and should be corrected as necessary for safety.(Picture 9)

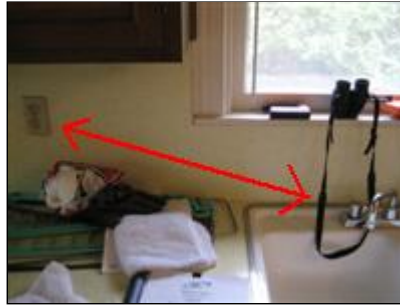
B. Picture 2 NO GFCI WITHIN 3' OF WATER SOURCE

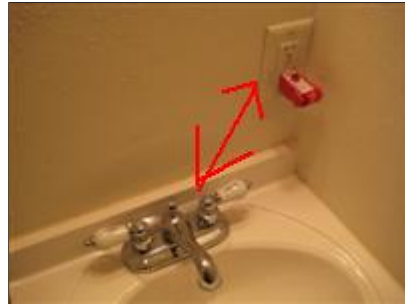
B. Picture 4 NO GFCI IN BATHROOMS

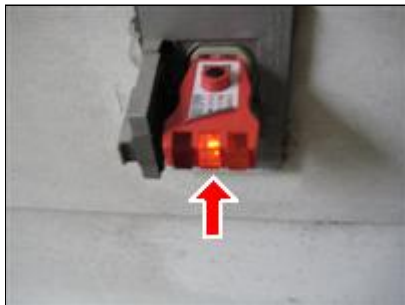
(3) The electrical outlets have "open grounds" ( Non-grounded ) at most areas inside the structure. Non-grounded outlet(s) are currently acceptable, however, it should be labeled a non-grounded outlet. Open grounded are not as safe as a grounded electrical outlet(s). Some appliances will not function without proper grounding.(Picture 6)(Picture 7)(Picture 8)

B. Picture 6 OPEN GROUNDS

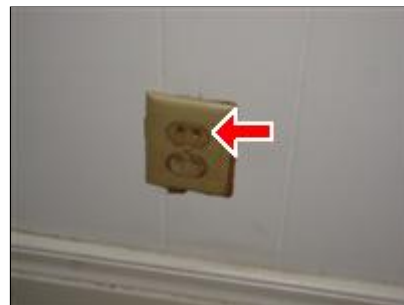
B. Picture 10

(4) Outlets at various locations inside structure are "two-wire" and are not grounded. Two wire outlets are acceptable due to age of structure, but some appliances cannot be plugged into outlets or will not work without a ground. Recommend repair or replace as necessary.(Picture 9)(Picture 10)

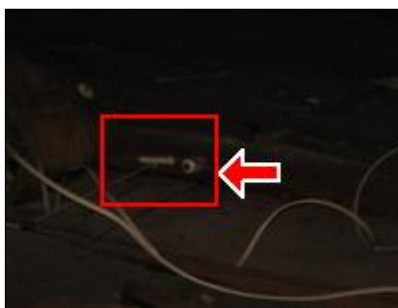
B. Picture 16

(9) The attic is poorly insulated and "Knob and Tube" wiring is present. As a safety rule Knob and Tube wiring should never have insulation covering this wire or over heating can occur. If new insulation is added, an electrical contractor should first replace knob and tubing wires with updated wiring.(Picture 15)(Picture 16)

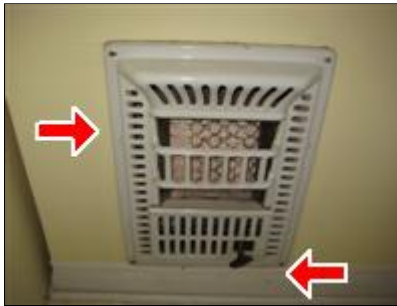
A. Picture 2 DISALLOWED BY STANDARDS

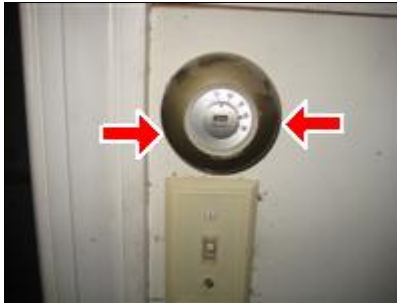
A. Picture 4 NON-FUNCTIONING

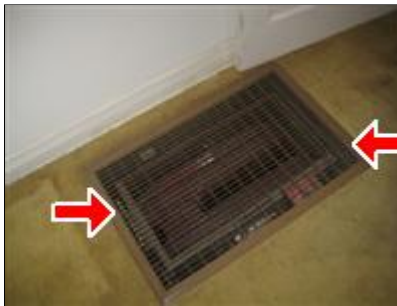
🏠 (2) Old heating equipment should be updated, serviced, and/or removed as necessary for normal function. Gas fired wall heaters and floor furnaces are no longer allowed by today's standards and should be thoroughly evaluated or serviced as necessary before further usage by a heating and cooling expert.(Picture 5)(Picture 6)(Picture 7)(Picture 8)

A. Picture 6 FLOOR REGISTER
